# FACILITY CONDITION ASSESSMENT

FACILITY CONDITION ASSESSMENT  
OF  
CIRCLE VIEW ELEMENTARY  
6261 HOOKER LANE  
HUNTINGTON BEACH, CALIFORNIA 92647

June 6, 2016

May 4, 2016

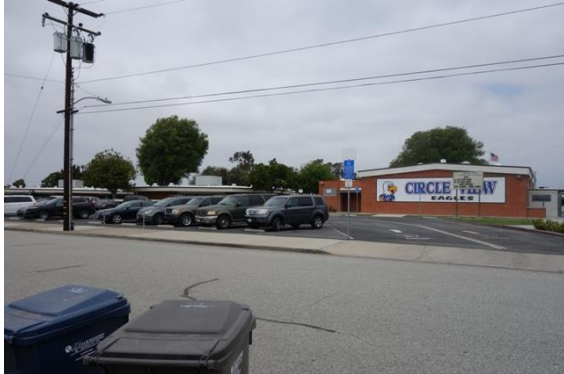
Photo #1: Circle View Entrance

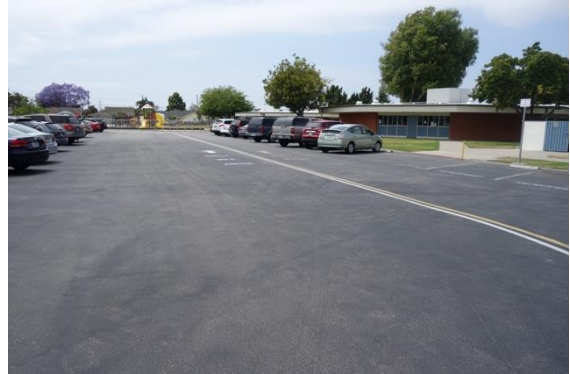
Photo #2: Circle View Parking

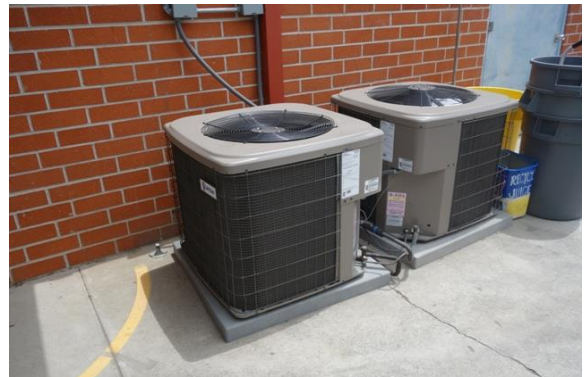
Photo #4: MPR Split Unit Condensers

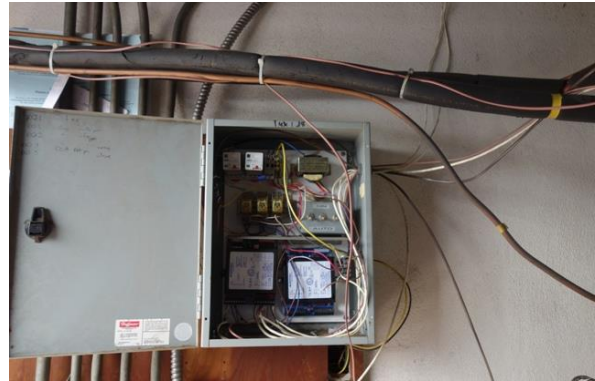
Photo #6: HVAC Controls

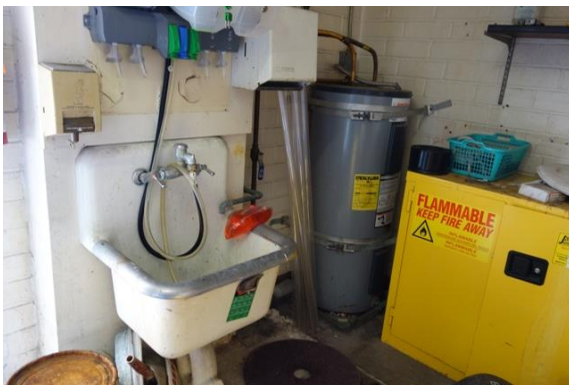
Photo #11: American Water Heater – 40 Gal - 1992

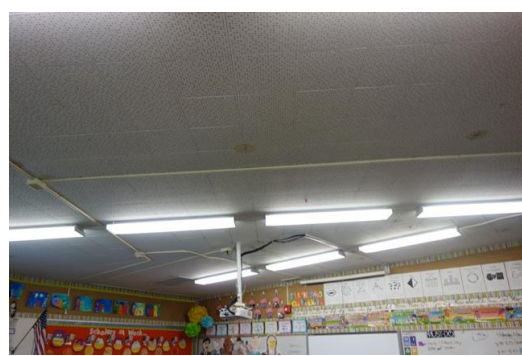
Photo #30: Acoustical Ceiling Tiles

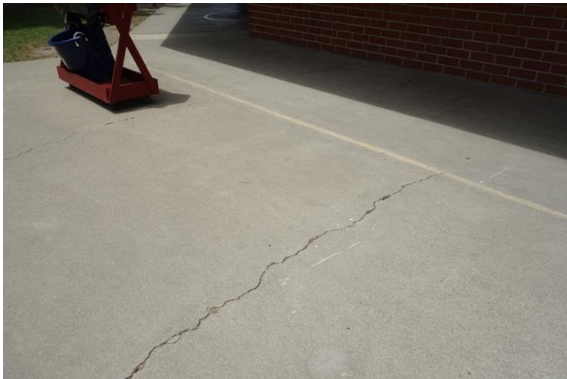
Photo #39: Pedestrian Walk Deficiency

5.2	437752	G2031 Concrete Sidewalk, Repair	0	0	0	200	SF	\$28.94	\$5,789	\$5,789																				\$5,789
6.3	443228	B3011 Roof, Modified Bituminous, Replace	20	15	5	13604	SF	\$9.01	\$122,508						\$122,508															\$122,508

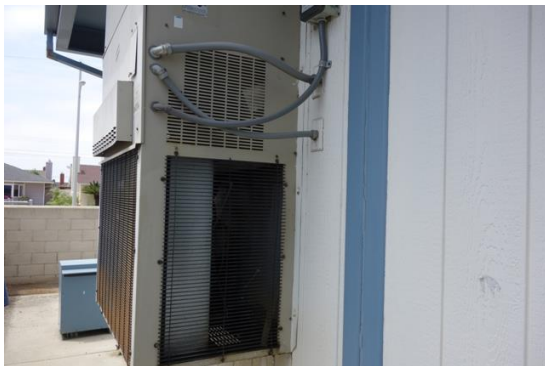
Photo #41: MarvAir Heat Pump

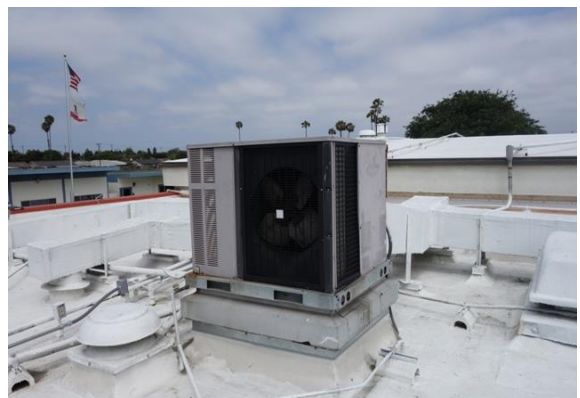
Photo #48: MPR Package Unit

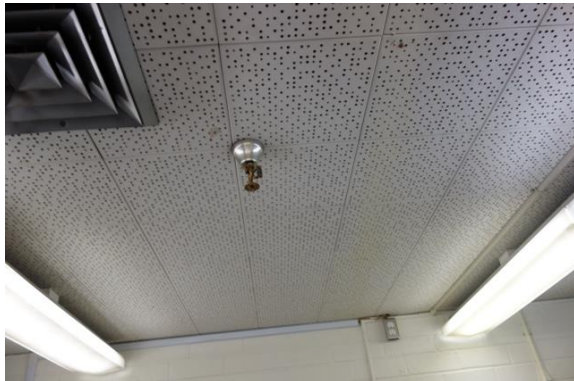
Photo #51: Acoustic Ceiling Tiles

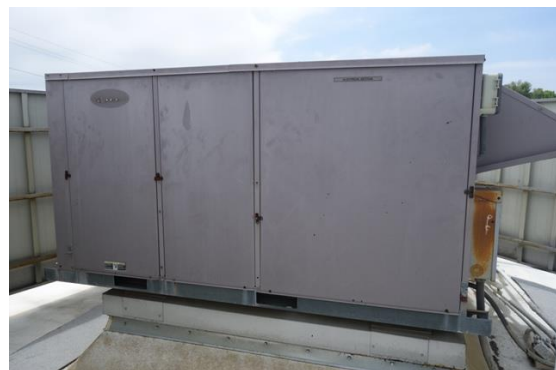
Photo #59: Carrier RTU – 25 Ton (typical)

- Replace Rooftop Package Units
- Add Digital Control (DDC) System
- Replace Heat Pumps on Portables

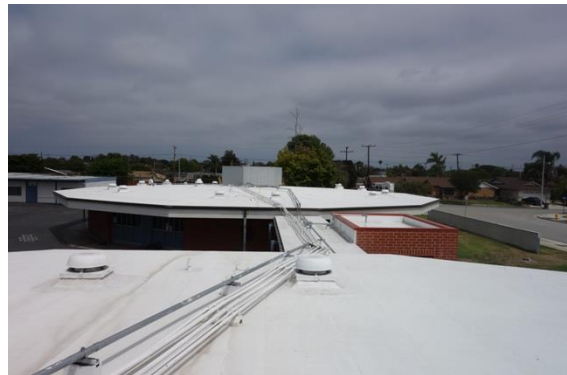
Photo #60: Elastomeric Roof Coating (typical)
