FACILITY CONDITION ASSESSMENT

FACILITY CONDITION ASSESSMENT
OF

HARBOUR VIEW ELEMENTARY
4343 PICKWICK CIRCLE
HUNTINGTON BEACH, CALIFORNIA 92647

May 31, 2016

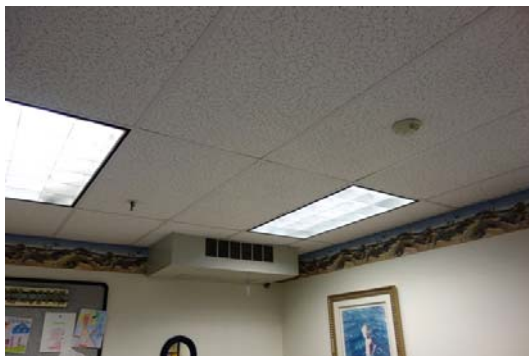
Photo #10: Fan Coil Units with Suspended Ceiling

7.1	Located West Section of Original School.	437035	D3041 Fan Coil Unit, Hydronic, 2,401 to 3,200 CFM, Replace	15	15	* 0	31	EA	\$5,597.27	\$173,515	\$173,515																\$173,515					\$347,031

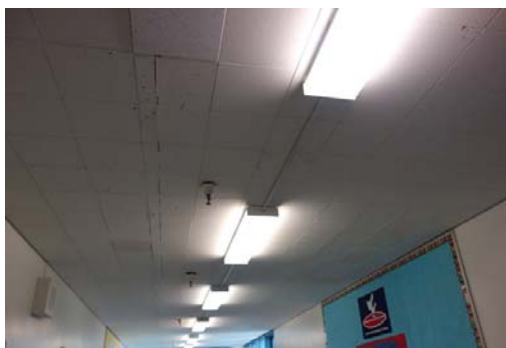
Photo #12: Hallway Original ACT

8.1	Hallways in West Section	439431	C3032 Interior Ceiling Finish, Acoustical Tile (ACT), Replace	20	20	* 0	4000	SF	\$3.11	\$12,444											\$12,444											\$12,444

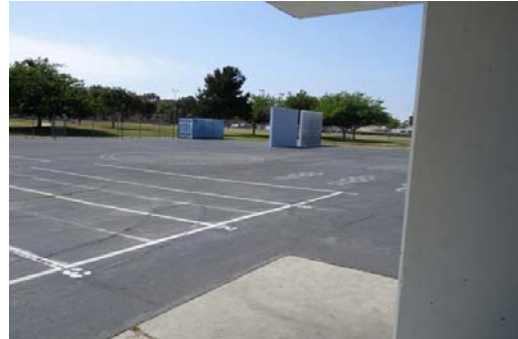
Photo #20: Asphalt Play Surface

5.2	Playground area	439446	G2047 Basketball/Tennis/Play Court, Asphalt, Seal & Stripe	5	5	* 0	56822	SF	\$0.38	\$21,621	\$21,621						\$21,621					\$21,621					\$21,621					\$86,483

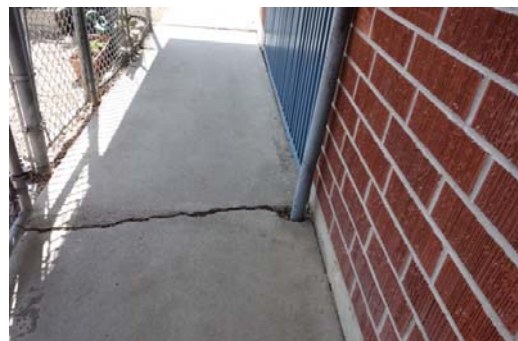
Photo #24: Sidewalk Damage

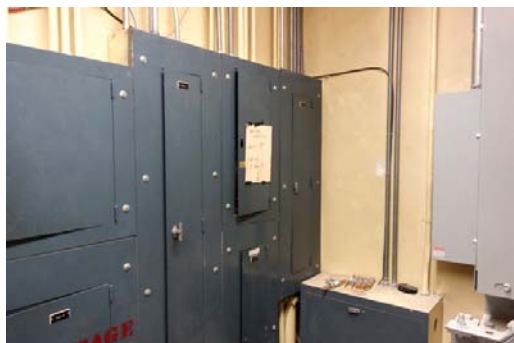
Photo #29: Original Circuit Panels

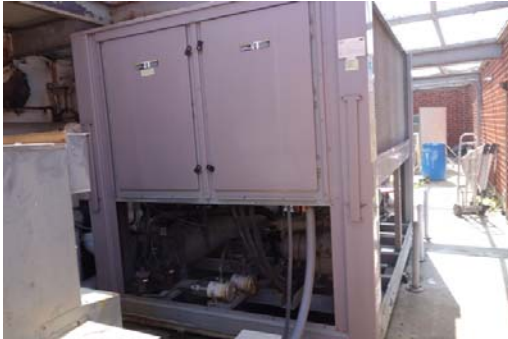
Photo #31: Carrier Air Cooled Chiller

7.1	Outdoor Mechanical Area	437028	D3031 Chiller, Air-Cooled, 81 to 90 Ton, Replace	25	16	* 9	1	EA	\$133,882.94	\$133,883											\$133,883											\$133,883

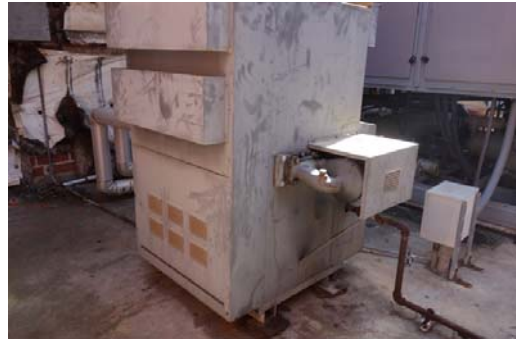
Photo #32: Teledyne Boiler

6.3	Main roof	439430	B3011 Roof, Built-Up, Replace	20	13	* 7	60598	SF	\$12.96	\$785,435			\$785,435																			\$785,435
7.1	Outside Mechanical Area	437034	D3021 Boiler, Gas, 26 to 50 MBH, Replace	25	16	* 9	1	EA	\$10,821.00	\$10,821											\$10,821											\$10,821

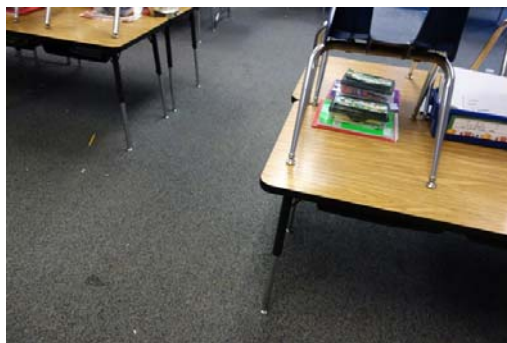
Photo #48: Class Room Carpeting

8.1	Classrooms	439432	C3025 Interior Floor Finish, Carpet Tile Commercial-Grade, Replace	10	10	* 0	48000	SF	\$6.96	\$334,219				\$334,219										\$334,219								\$668,438

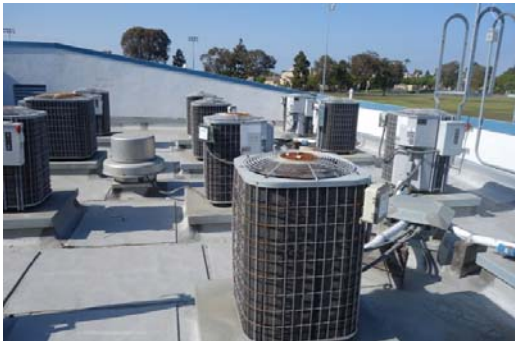
Photo #55: Roof Mounted Split Unit Compressors for East Section

7.1	East Roof On 2004 Phase	437152	D3032 Condensing Unit/Heat Pump, Split System, 3.5 Ton, Replace	15	11	* 4	16	EA	\$4,129.27	\$66,068					\$66,068																\$66,068	\$132,137

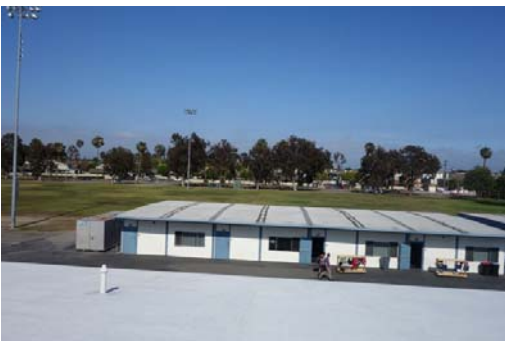
Photo #59: Portable Roofs

6.3	Portable Classroom on East Side of Building	439429	B3011 Roof, Asphalt Shingle, Replace	20	20	* 0	7000	SF	\$3.42	\$23,944	\$23,944																					\$23,944

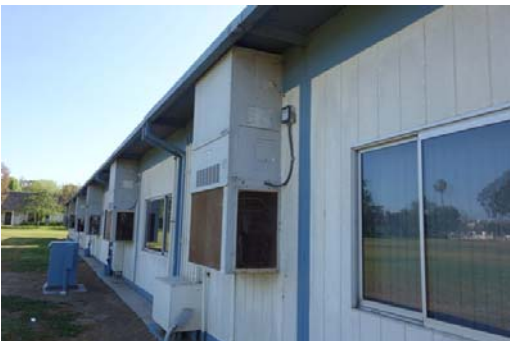
Photo #60: Portable HP

7.1	Portables	437154	D3052 Heat Pump, 3.5 to 5 Ton, Replace	15	15	* 0	5	EA	\$8,928.22	\$44,641	\$44,641																\$44,641					\$89,282
7.1	Pelican Hall	439428	D3052 Heat Pump, 3.5 to 5 Ton, Replace	15	15	* 0	1	EA	\$8,928.22	\$8,928											\$8,928											\$8,928
