FACILITY CONDITION ASSESSMENT

FACILITY CONDITION ASSESSMENT
OF
OCEAN VIEW SCHOOL DISTRICT
OAK VIEW PRESCHOOL
17131 EMERALD LANE
HUNTINGTON BEACH, CALIFORNIA 92647

119317.16R000-010.017

May 29, 2016

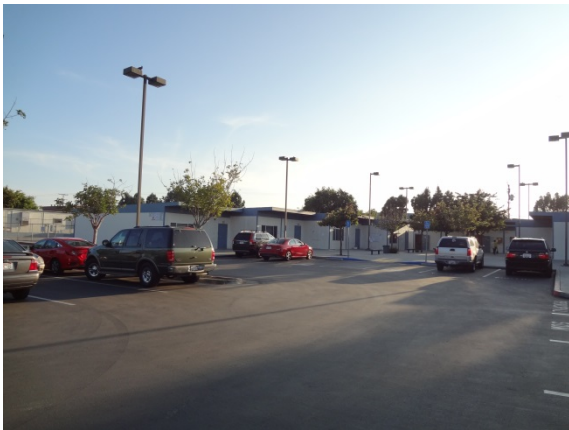
Photo #3: Asphalt Parking Lot

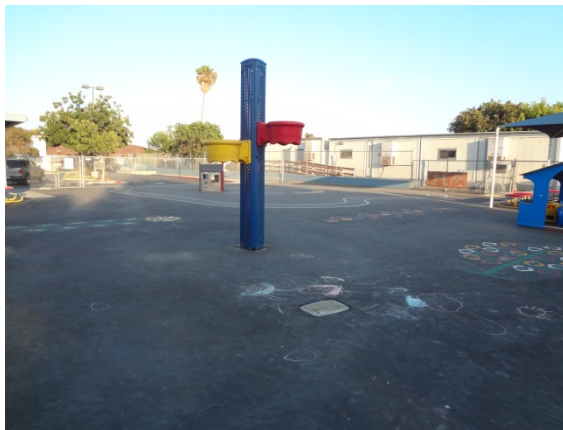
Photo #9: Asphalt Playground

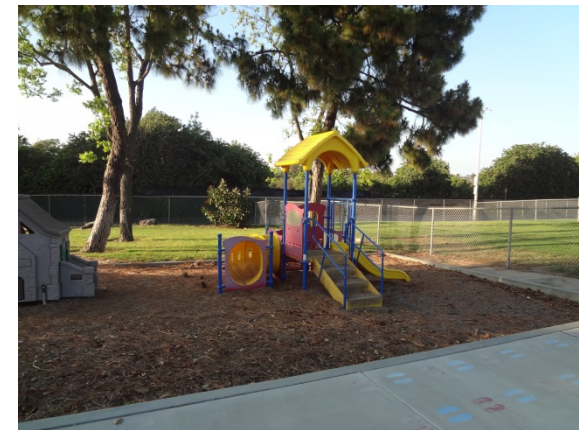
Photo #10: Wood Chip Playground with Play Structure

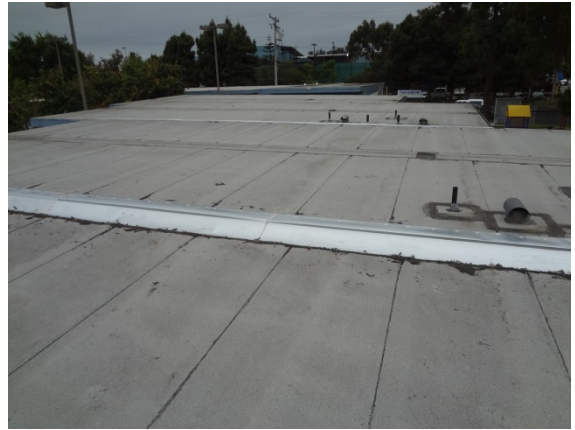
Photo #14: Asphalt Membrane Roof

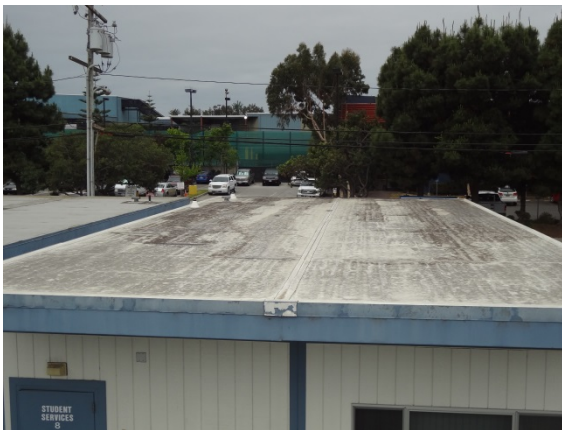
Photo #15: Room 8 Single Ply Membrane Roof

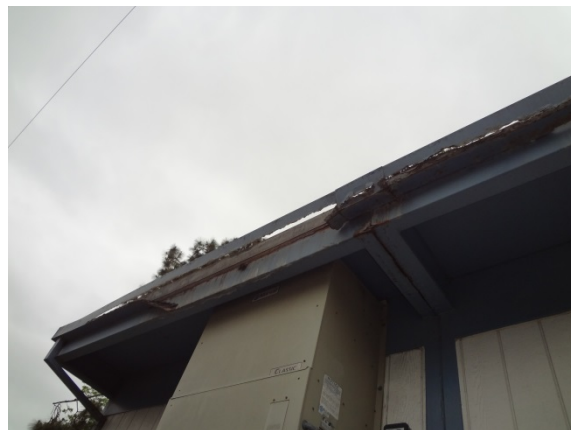
- Replacement of gutters and downspouts for Room 9

Photo #18: Corroding Structural Members and Gutter System Room 9

Report Section	Location	Description	ID	Cost Description	Quantity	Unit	Unit Cost	Subtotal	Deficiency	Repair Estimate *
6.3	Room 9		439488	Gutters & Downspouts, Aluminum w/ Fittings, Replace	45	LF	\$8.37	\$377		\$377
Immediate Repairs Total										\$377

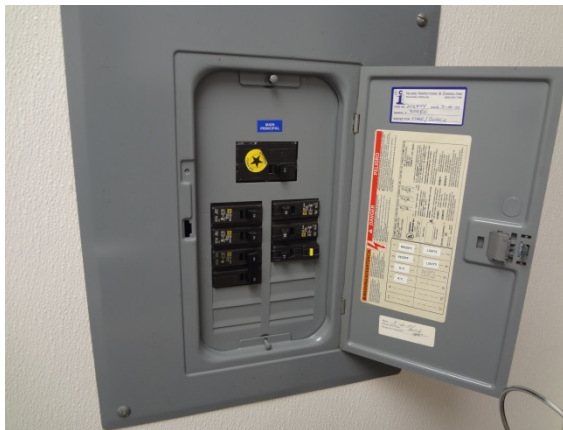
Photo #21: Classroom Electrical Panel

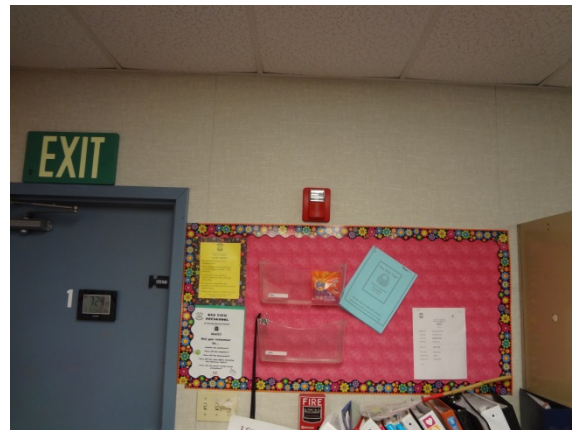
Photo #22: Fire Alarm Device and Illuminated Exit Sign

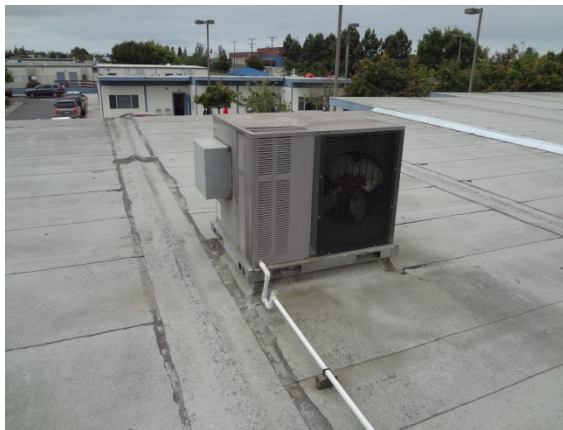
Photo #27: Office Rooftop Unit

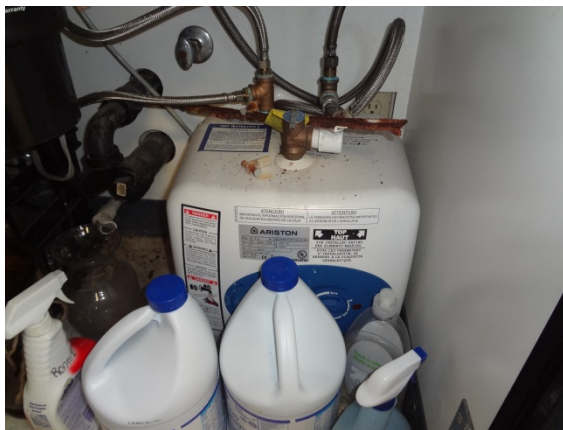
Photo #29: Office Point of Use Electric Water Heater

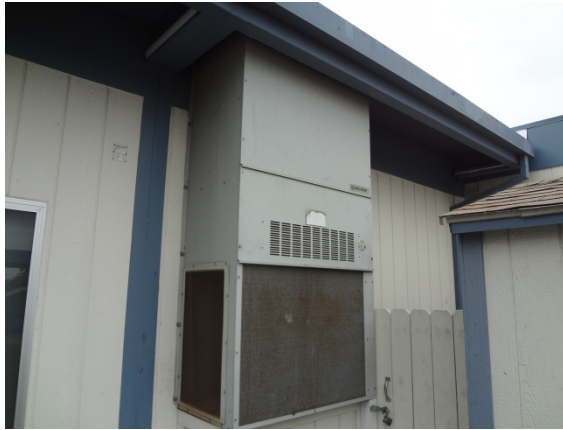
Photo #31: Classroom Heat Pump

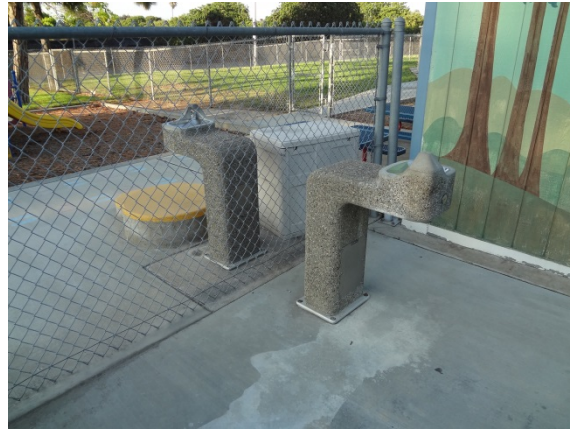
Photo #32: Exterior Drinking Fountains
