FACILITY CONDITION ASSESSMENT

FACILITY CONDITION ASSESSMENT
OF
OCEAN VIEW SCHOOL DISTRICT
PLEASANT VIEW / OVPP ELEMENTARY
16692 LANDAU LANE
HUNTINGTON BEACH, CALIFORNIA 92647

May 29, 2016

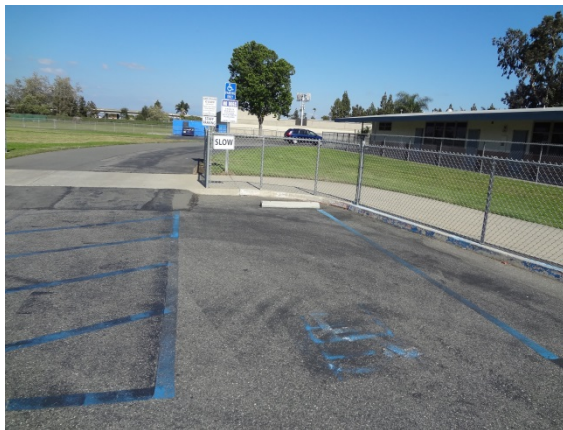
Photo #9: Single ADA Parking Stall

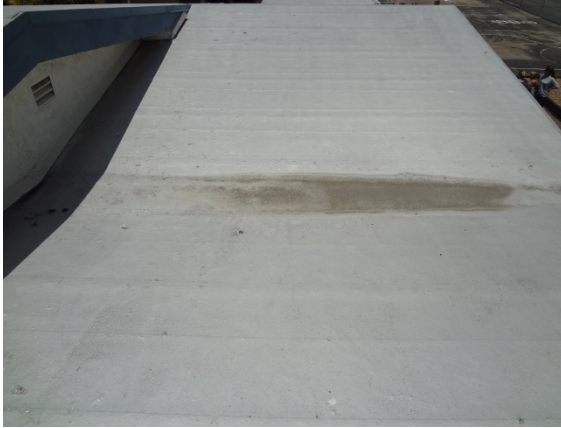
Photo #19: Low Point with Potentially Ponding Issues

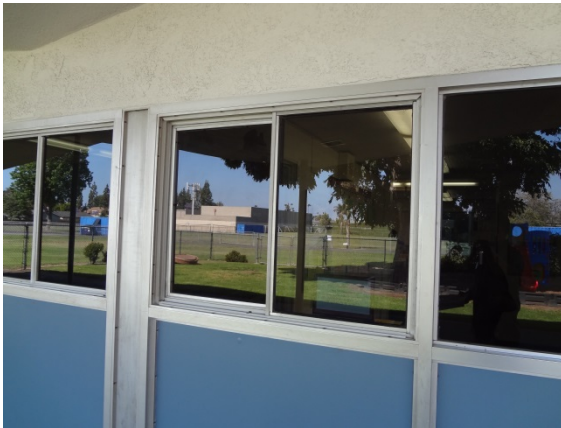
Photo #21: Single Pane Slider Window

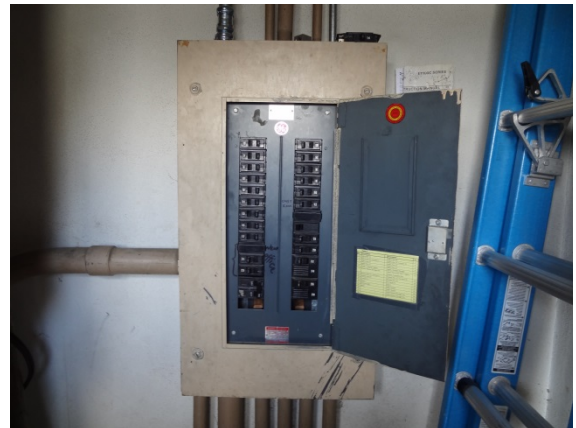
Photo #24: Typical Electrical Panel - Original

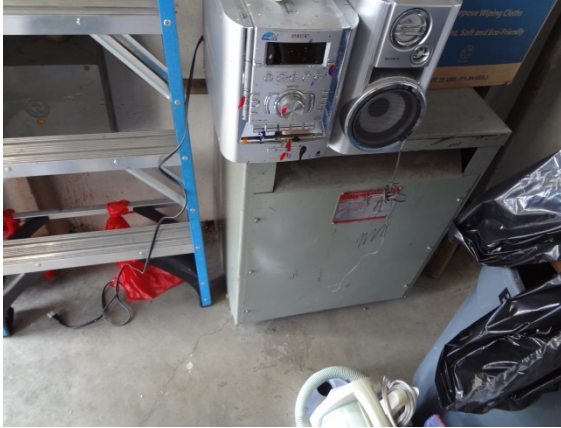
Photo #25: Transformer - Original

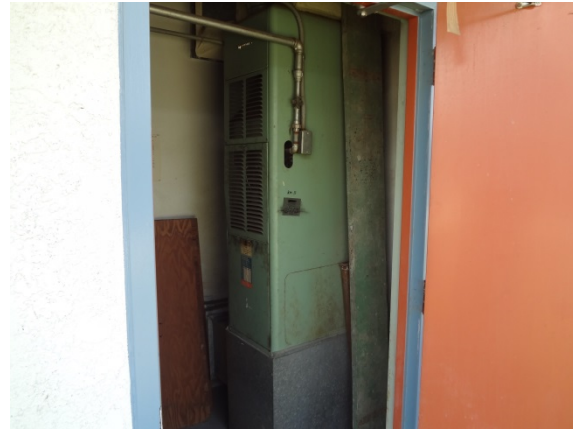
Photo #32: Gas Furnace - Original

7.1	Mechanical Closet	438004	Furnace, Gas, 51 to 100 MBH, Replace	1	EA	\$3,801.45	\$3,801	\$3,801
7.1	Mechanical Closet	438005	Furnace, Gas, 51 to 100 MBH, Replace	1	EA	\$3,801.45	\$3,801	\$3,801

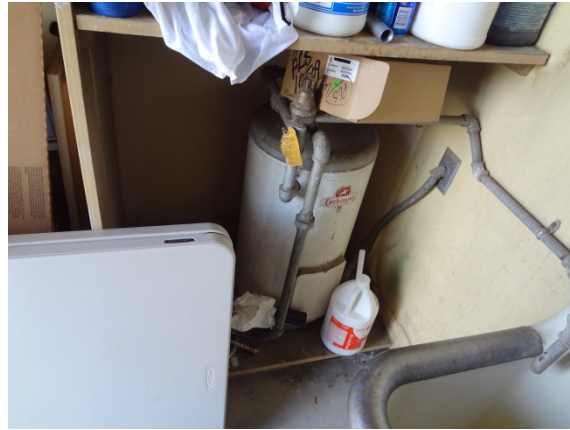
Photo
#38: Failed Electric Water Heater

7.2	Janitor Closet	438058	Water Heater, Electric, Residential, 16 to 29 GAL, Replace	1	EA	\$1,249.92	\$1,250	\$1,250
7.2	Mechanical Closet	438037	Water Heater, Electric, Residential, 16 to 29 GAL, Replace	1	EA	\$1,249.92	\$1,250	\$1,250
