FACILITY CONDITION ASSESSMENT

FACILITY CONDITION ASSESSMENT
OF
VILLAGE VIEW ELEMENTARY
5361 SISSON DRIVE
HUNTINGTON BEACH, CALIFORNIA 92649

EMG
10461 Mill Run Circle, Suite 1100
Owings Mills, Maryland 21117
800.733.0660
www.emgcorp.com

June 3, 2016

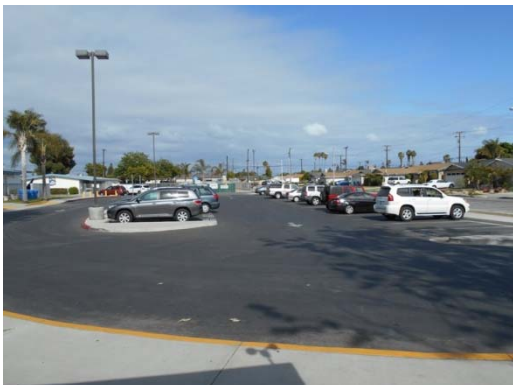
Photo #11: Parking Lot

5.2	Parking lot	436385	G2022 Asphalt Pavement, Parking Lot, Seal & Stripe	5	2	3	44500	SF	\$0.38	\$16,888				\$16,888					\$16,888					\$16,888					\$16,888			\$67,551

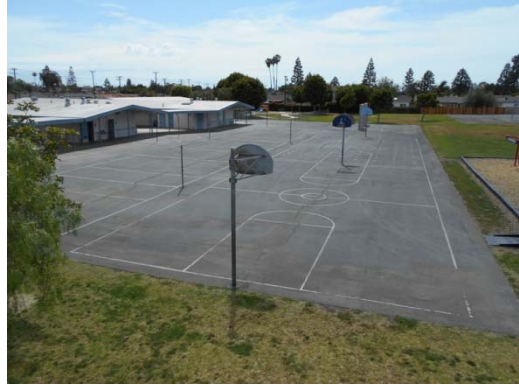
Photo #14: Basketball Court

5.5	Basketball and play courts	436404	G2047 Basketball/Tennis/Play Court, Asphalt, Seal & Stripe	5	2	3	74000	SF	\$0.38	\$28,157				\$28,157					\$28,157					\$28,157					\$28,157			\$112,628

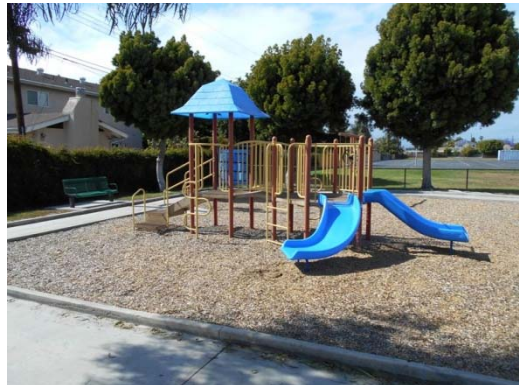
Photo #16: Playground Equipment

5.2	Throughout the site	436390	G2031 Concrete Sidewalk, Replace	30	30	0	240	SF	\$19.82	\$4,757	\$4,757																					\$4,757						
5.5	Playgrounds	436399	G2047 Play Structure, Medium, Replace	20	10	10	2	EA	\$40,005.63	\$80,011											\$80,011											\$80,011

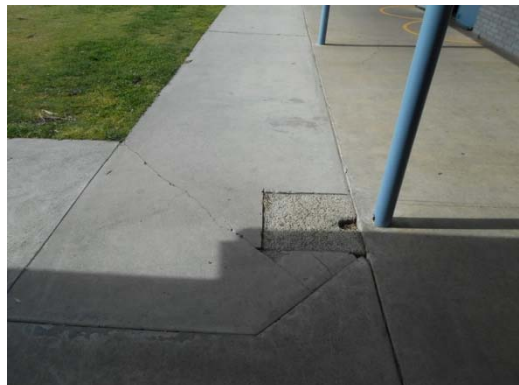
Photo #18: Concrete Sidewalk

- Replacement of some areas of concrete sidewalk with broken and displaced concrete slab
- Multiple remodeling items to satisfy ADA requirements

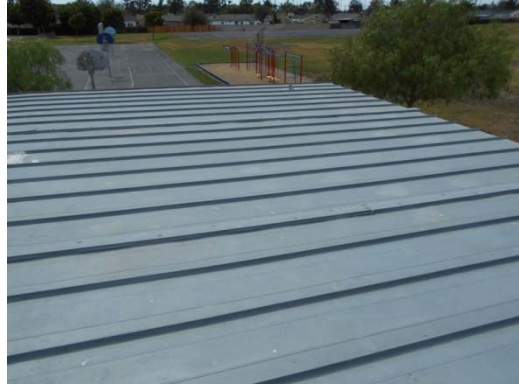
Photo #20: Metal Roof

6.3	Covered Eating Area	437736	B3011 Roof, Metal, Replace	40	30	10	2400	SF	\$12.45	\$29,878											\$29,878											\$29,878						
6.4	Throughout the buildings	436383	B2011 Exterior Wall, Painted Surface, 1-2 Stories, Prep & Paint	10	5	5	18500	SF	\$2.87	\$53,108						\$53,108										\$53,108						\$106,216

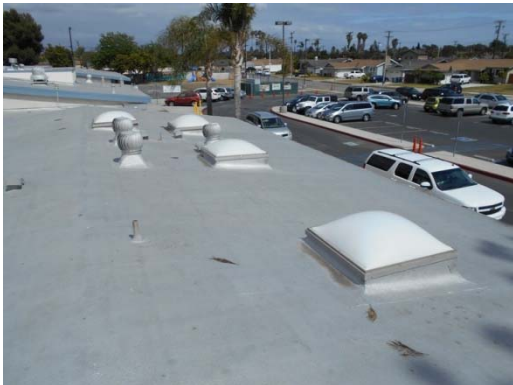
Photo #21: Built-up Roof with Skylights

6.3	Original Buildings built in 1962	436396	B3011 Roof, Built-Up, Replace	20	14	6	42873	SF	\$12.96	\$555,694							\$555,694							\$28,157					\$28,157			\$555,694

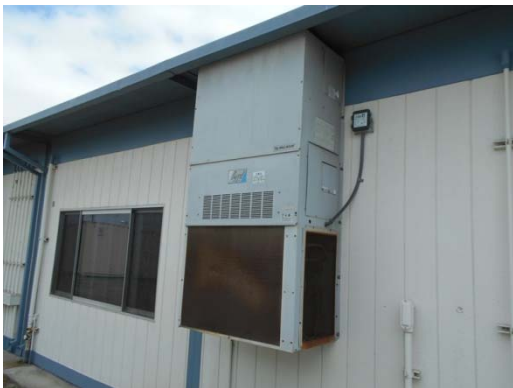
Photo #29: Wall Mounted Heat Pump

7.1	Wall of portable buildings built in 1998	436379	D3052 Heat Pump, 3.5 to 5 Ton, Replace	15	13	2	6	EA	\$8,928.22	\$53,569			\$53,569															\$53,569				\$107,139

- Replacement of heat pump units on portable buildings
- Replacement of some areas of concrete sidewalk with broken and displaced concrete slab
- Multiple remodeling items to satisfy ADA requirements
- Modernization of original 1960's electrical system
- Modernization of original 1960's plumbing system
- Replacement of original heating equipment in multi-purpose room and teachers' lounge
- Addition of new air-conditioning equipment in multi-purpose room, kitchen and teachers' lounge
- Replacement of split system air conditioning units in classrooms No. 21 through No. 23
- Replacement of original wall mounted heat pump units on portable buildings built in 1998

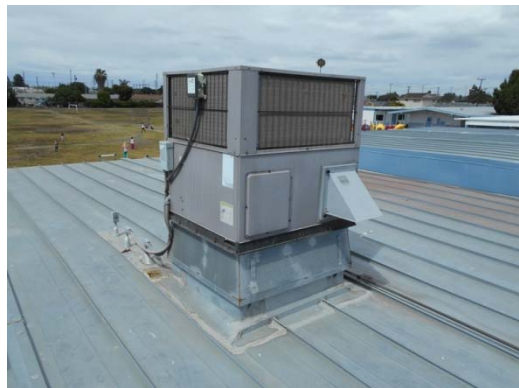
Photo #30: Roof Mounted Heat Pump

7.1	roofs of portable buildings child care and library	436398	D3052 Heat Pump, 3.5 to 5 Ton, Replace	15	11	* 4	3	EA	\$8,928.22	\$26,785		\$26,785															\$26,785					\$53,569

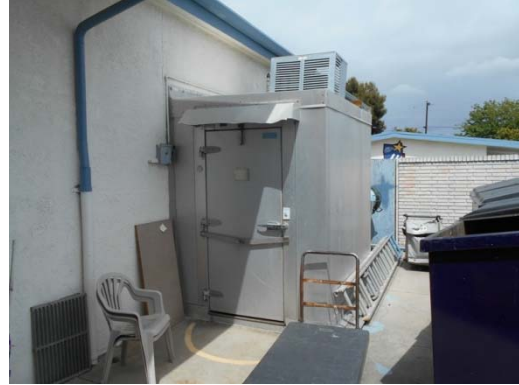
Photo #32: Walk-in Freezer

8.3	Kitchen	436397	E1093 Freezer/Cooler, Commercial, Walk-In, Replace	15	8	7	1	EA	\$22,317.14	\$22,317								\$22,317														\$22,317						
	Teachers' lounge	437953	D3032 Condenser, Air-Cooled, 3 Ton, Replace	15	13	2	2	EA	\$2,755.13	\$5,510			\$5,510															\$5,510				\$11,021						
Totals, Unescalated											\$81,189	\$38,016	\$2,551,650	\$45,045	\$0	\$328,847	\$555,694	\$142,480	\$45,045	\$0	\$114,173	\$96,589	\$14,021	\$45,045	\$0	\$328,847	\$110,244	\$67,345	\$45,045	\$0	\$4,609,274				\$0			
Location Factor (1.00)											\$0	\$0	\$0	\$0	\$0	\$0	\$0	\$0	\$0	\$0	\$0	\$0	\$0	\$0	\$0	\$0	\$0	\$0	\$0	\$0	\$0	\$0	\$0	\$0	\$0	\$0	\$0	\$0
Totals, Escalated (3.0% inflation, compounded annually)											\$81,189	\$39,157	\$2,707,046	\$49,222	\$0	\$381,224	\$663,528	\$175,232	\$57,061	\$0	\$153,439	\$133,701	\$19,991	\$66,150	\$0	\$512,333	\$176,909	\$111,311	\$76,686	\$0	\$5,404,178							\$0

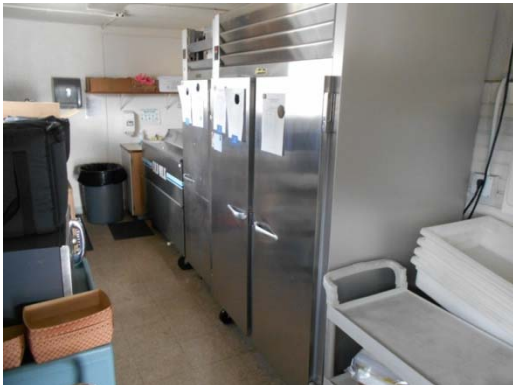
Photo #33: Reach-in Refrigerators

8.3	Kitchen	436377	E1093 Food Warmer, Replace	15	8	7	1	EA	\$1,551.91	\$1,552								\$1,552														\$1,552						
8.3	Kitchen	436391	E1093 Refrigerator, Commercial Kitchen, Replace	15	8	7	3	EA	\$1,406.90	\$4,221								\$4,221														\$4,221

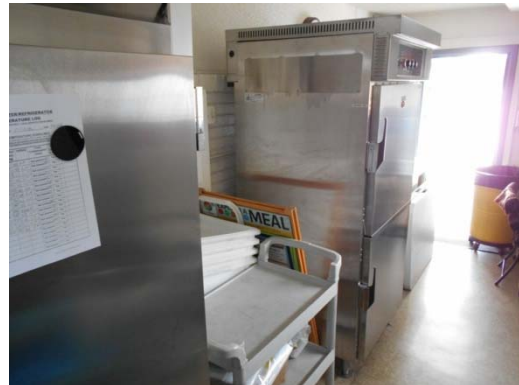
Photo #34: Food Warmer

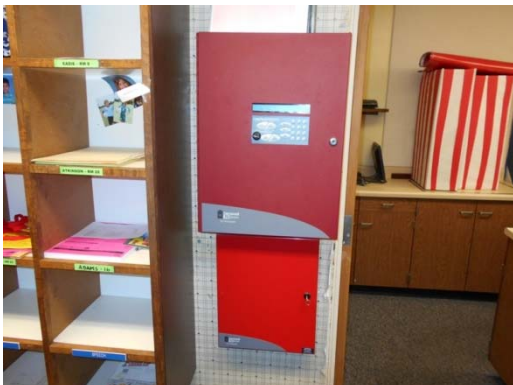
Photo #35: Central Fire Alarm Panel

7.4	Entire campus	436381	D5019 Electrical System, School, Upgrade	40	38	2	38726	SF	\$23.00	\$890,698			\$890,698																			\$890,698						
7.6	Main office	436389	D5037 Fire Alarm Control Panel, Multiplex, Replace	15	4	* 11	1	EA	\$4,284.35	\$4,284											\$4,284											\$4,284
