FACILITY CONDITION ASSESSMENT

FACILITY CONDITION ASSESSMENT
OF
VILLAGE VIEW ELEMENTARY
5361 SISSON DRIVE
HUNTINGTON BEACH, CALIFORNIA 92649

EMG
10461 Mill Run Circle, Suite 1100
Owings Mills, Maryland 21117
800.733.0660
www.emgcorp.com

June 3, 2016

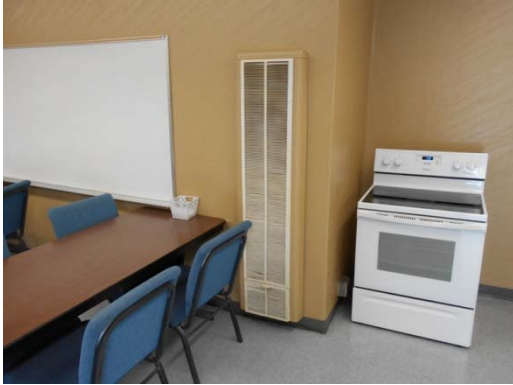
Photo #25: Furnace in Teachers' Lounge

7.1	Multi-purpose room	436603	D3051 Furnace, Gas, 151 to 200 MBH, Replace	20	18	2	2	EA	\$7,066.65	\$14,133				\$14,133																		\$14,133						
7.1	Teacher's lounge	436600	D3051 Furnace, Gas, 10 to 25 MBH, Replace	20	18	2	2	EA	\$1,997.57	\$3,995				\$3,995																		\$3,995
